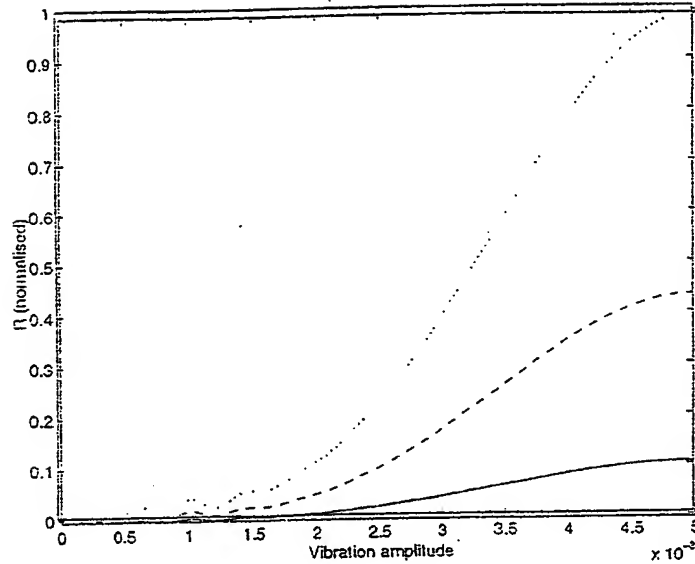
Figure 3 Simulated (normalised) power Doppler versus vibration amplitude for $A = 0.1$ (solid), $A = 0.2$ (dashed) and $A = 0.3$ (dotted). Parameters were as for Figure 1 with the exception of vibration frequency which was $f_v = 40Hz$.

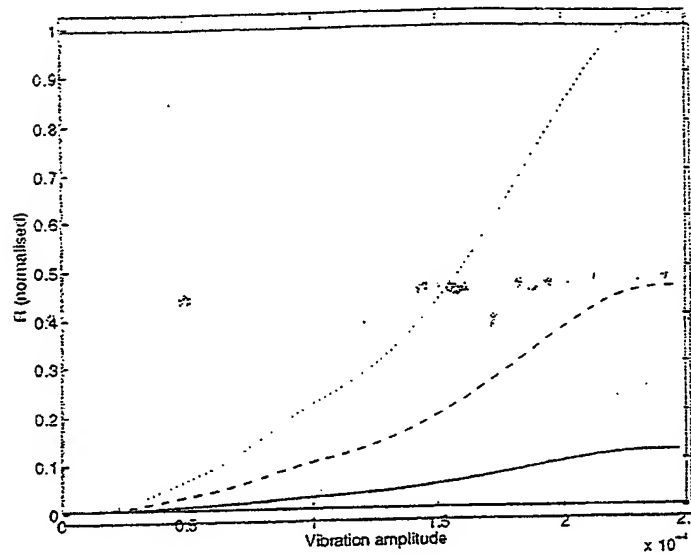
Figure 4 The previous Figure with the abscissa scaled.

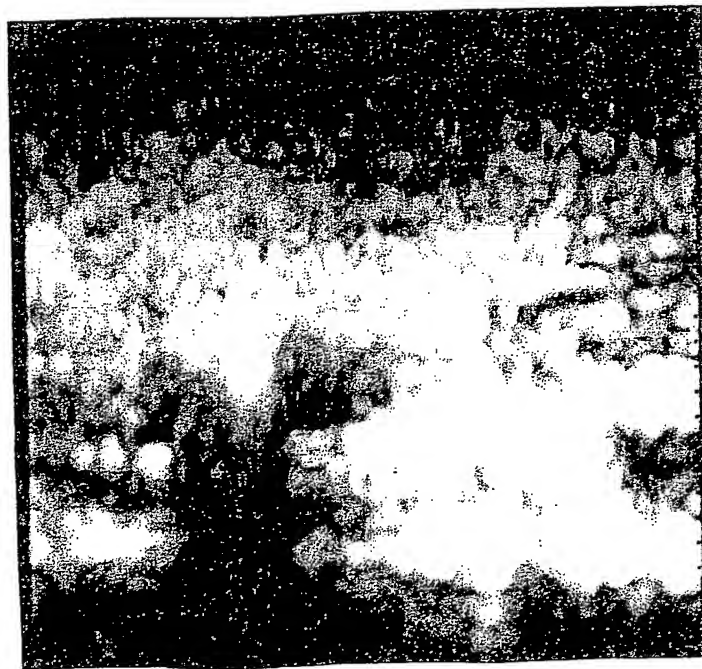
Figure 6

B-Scan

Power
Doppler

Sonoelastogram
